# ETHIOPIAN-GERMAN EXPEDITION TO WUQRO

REPORT ON THE PRELIMINARY SURVEY OF ABUNA GARIMA AND SITE  
MANAGEMENT ACTIVITIES AT THE ALMAQAH TEMPLE AT MEQABER GA'EWA  
AND ZIBAN ADI, NEAR WUQRO

OCTOBER 2016

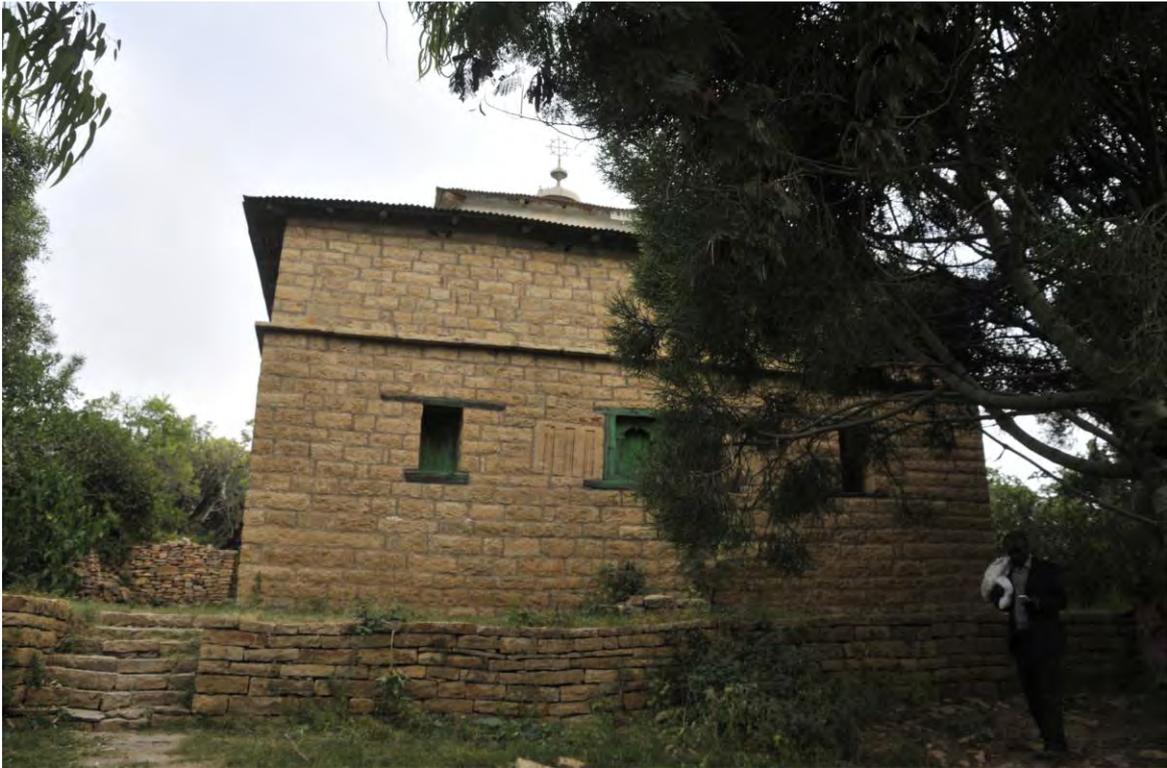
The significant degree of subsidence now affecting the church building likely has its causes in the nature of the platform upon which it stands (Figure 2), with the dry stone retaining wall unable to take the weight of the church without significant structural movement, a problem which may have been precipitated as a consequence of the recent wet season.

Figure 2: the main church building and platform on the southern slope of the mound (Area 1) (looking east) (photograph: S. Matthews)

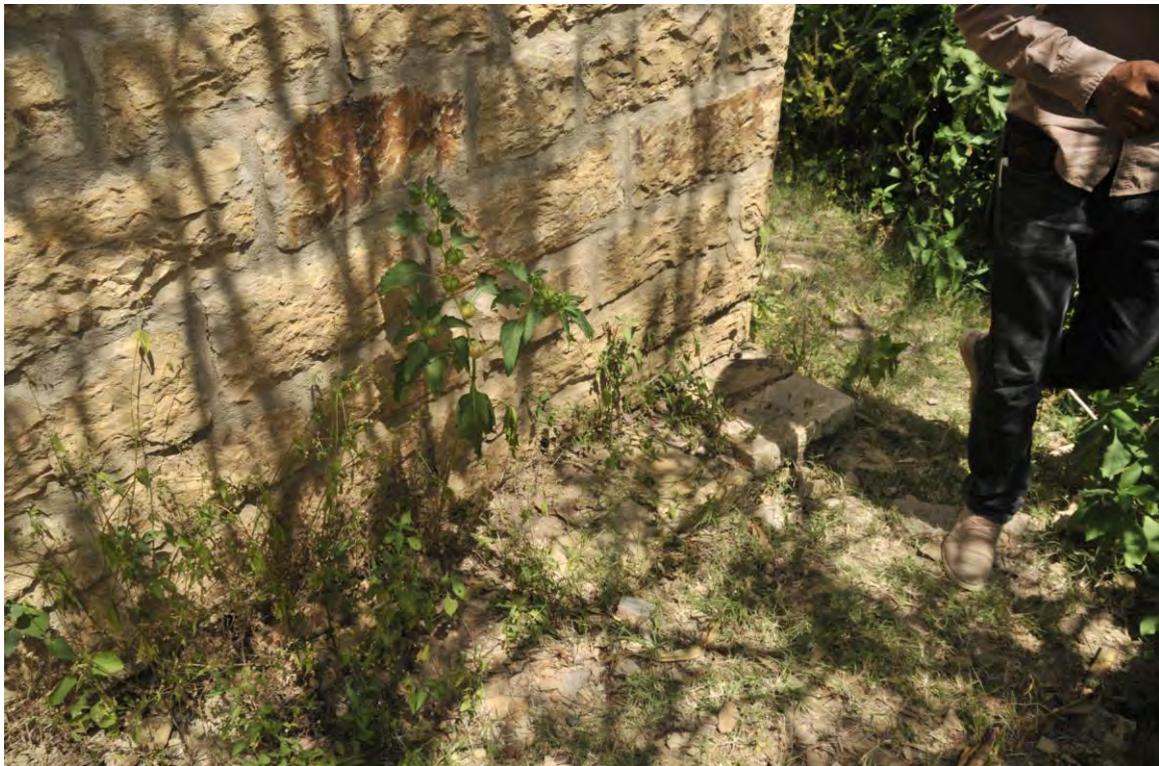
However, no surface finds were noted and no significant structural or sub-surface structural remains were identified. Along the eastern exterior edge of the church the remains of a wall are visible on the surface (Figure 5). This is likely the original line of the east wall of the church, prior to its rebuilding at some point in the 1980's.

Figure 5: the northeast corner of the main church building (Area 1), with possible foundation structure or original wall of the church (prior to its rebuilding in the 1980's) visible at ground level (looking northeast) (photograph: S. Matthews)

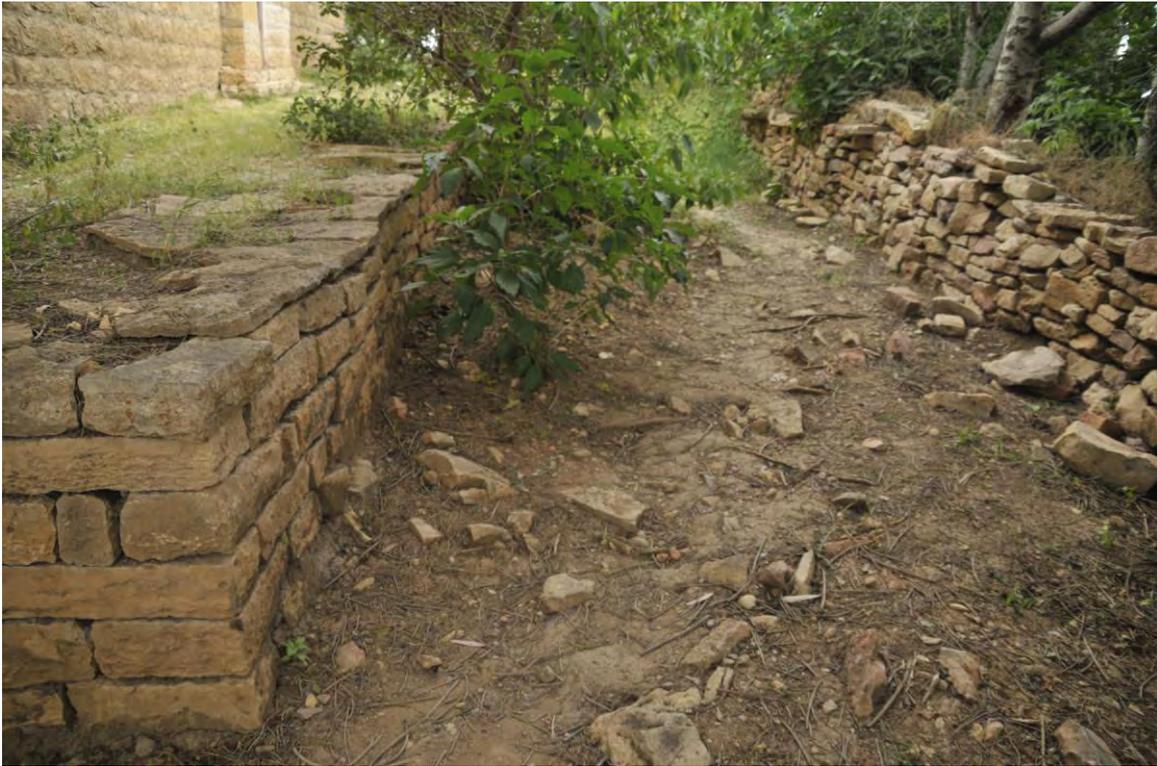
The areas to the west (Figure 15) and south (Figure 16) of the platform upon which the main church building sits provide the safest and most viable location for the placement of test trenches. Even here, though, there is a significant possibility for identifying structural elements related to any earlier building that might now lie beneath that of the church, given the propensity in pre-Aksumite times for ancillary structural elements, as seen at Meqaber Ga'ewa. As the north wall of the main church building appears to be located on the natural rise of the mound, it might be possible to also position a trench here, close to the building, without risking further subsidence. This would also provide an opportunity to establish the nature of the substructure, either in terms of the church on the site prior to its rebuilding or foundation structures. This also provides an opportunity to identify possible prehistoric structures which may also have been incorporated into later building phases.

Figure 16: south side of the church mound, beyond the platform (looking east) (photograph: S. Matthews)

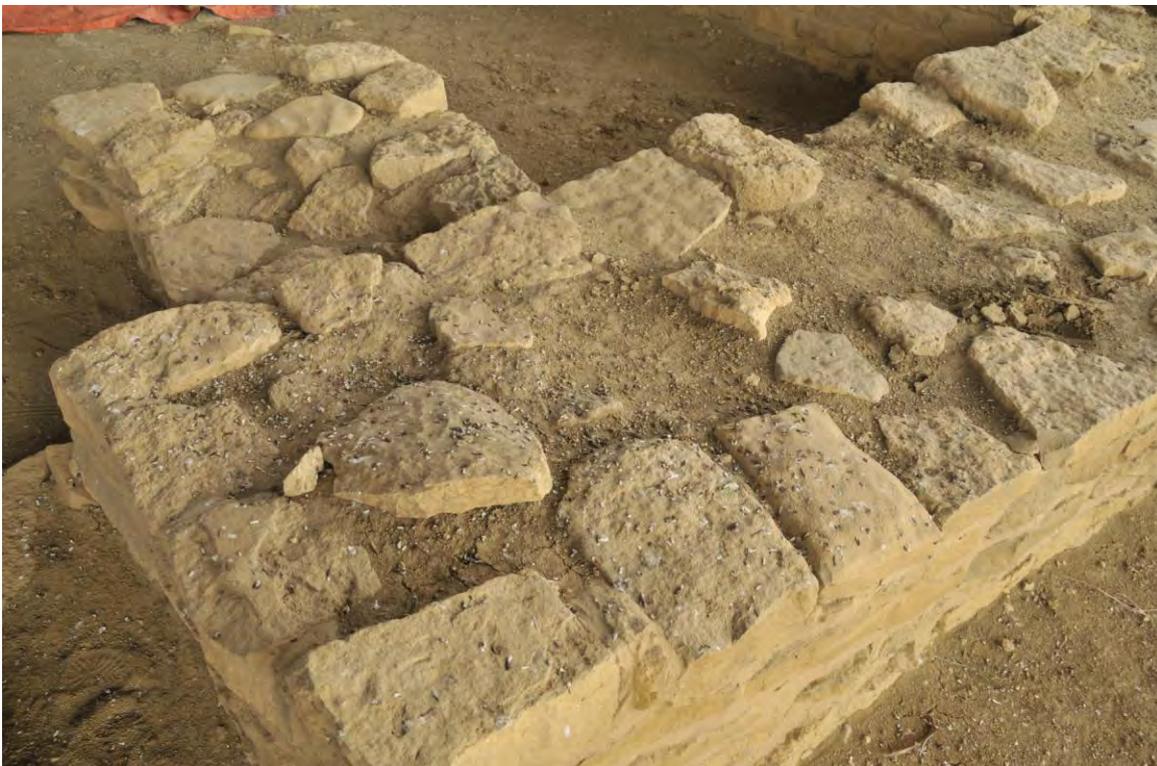
During the 2015 campaign, the net protecting the underside of the roof of the shelter had to be repaired, as several holes had formed and birds were once again beginning to nest inside the roof. IN that instance, the birds nest was carefully removed and the holes were repaired. A new, much smaller species of bird has now taken to occupying the underside of the shelter, and which are smaller enough to fit through the gaps in the net. As a consequence the site is heavily covered in bird faeces (Figure 17). Given its corrosive nature, it is a matter of some urgency that this is addressed.

Figure 17: bird faeces covering one of the restored walls of the Almaqah temple of Meqaber Ga'ewa (photograph: S. Matthews)

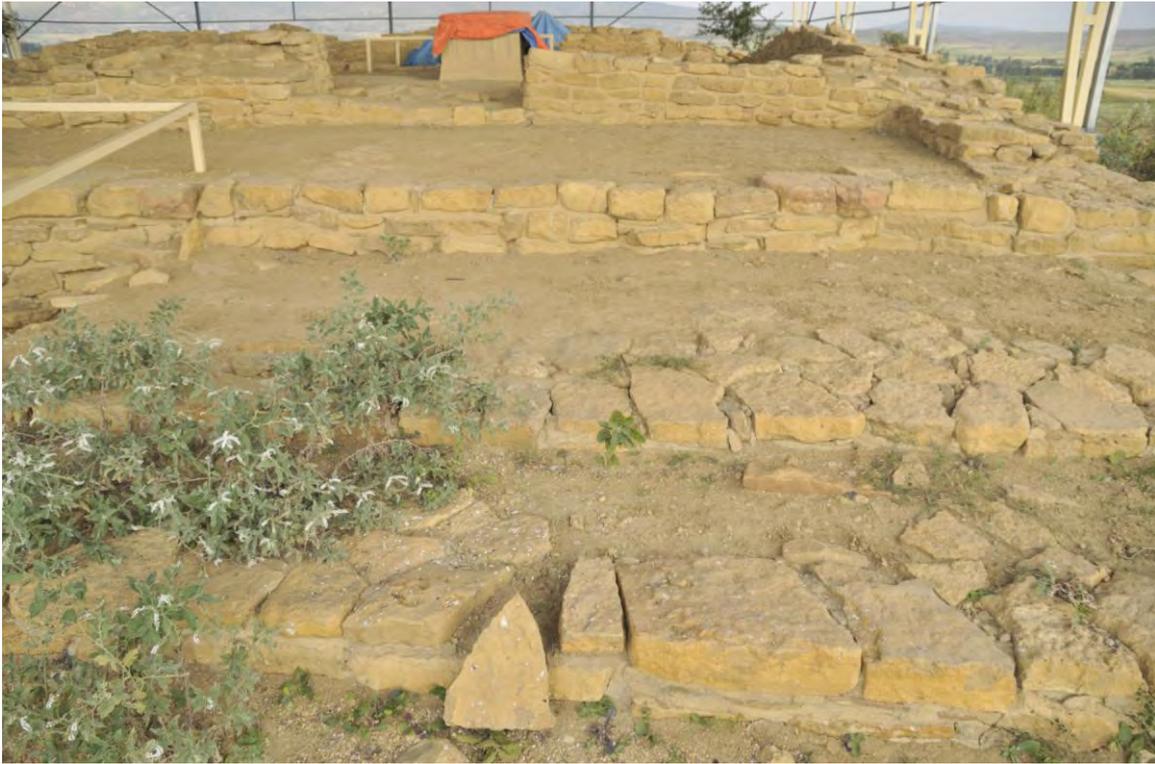
The main entrance to the Almaqah temple, which had been reconstructed and restored is beginning to wear, and many of the steps up into the temple are now beginning to become loose (Figure 18). These need to be reconsolidated, again as a matter of some urgency.

Figure 18: loose limestone blocks on the reconstructed entrance to the Almaqah temple at Meqaber Ga'ewa (photograph: S. Matthews)

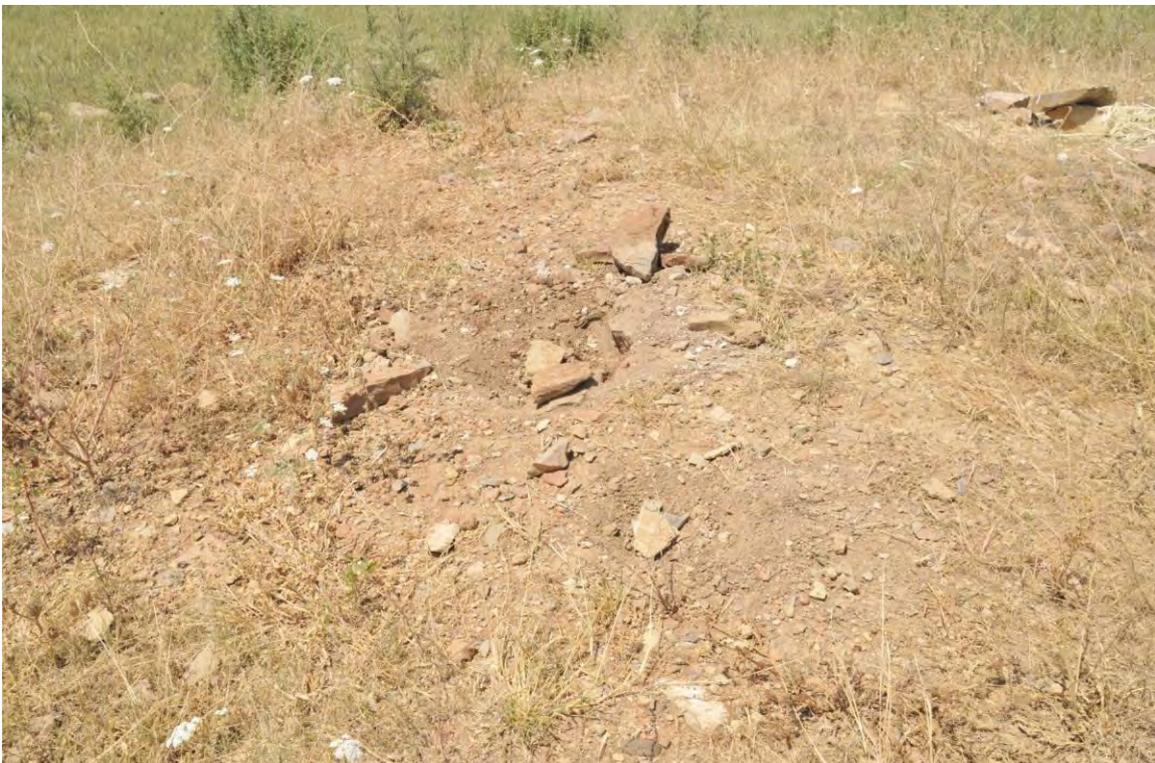
A small pit atop the mound (Figure 19), some 30 x 30 cm, and 25 cm deep, was noticed, presumably dug by a member of the public. However, the pit had clearly been abandoned as a consequence of the dense limestone rubble fill that forms the fill of the rooms of the building under the mound, and therefore no in situ archaeological deposits had been disturbed.

Figure 19: disturbance on the top of the mound by the members of the public (looking west) (photograph: S. Matthews)

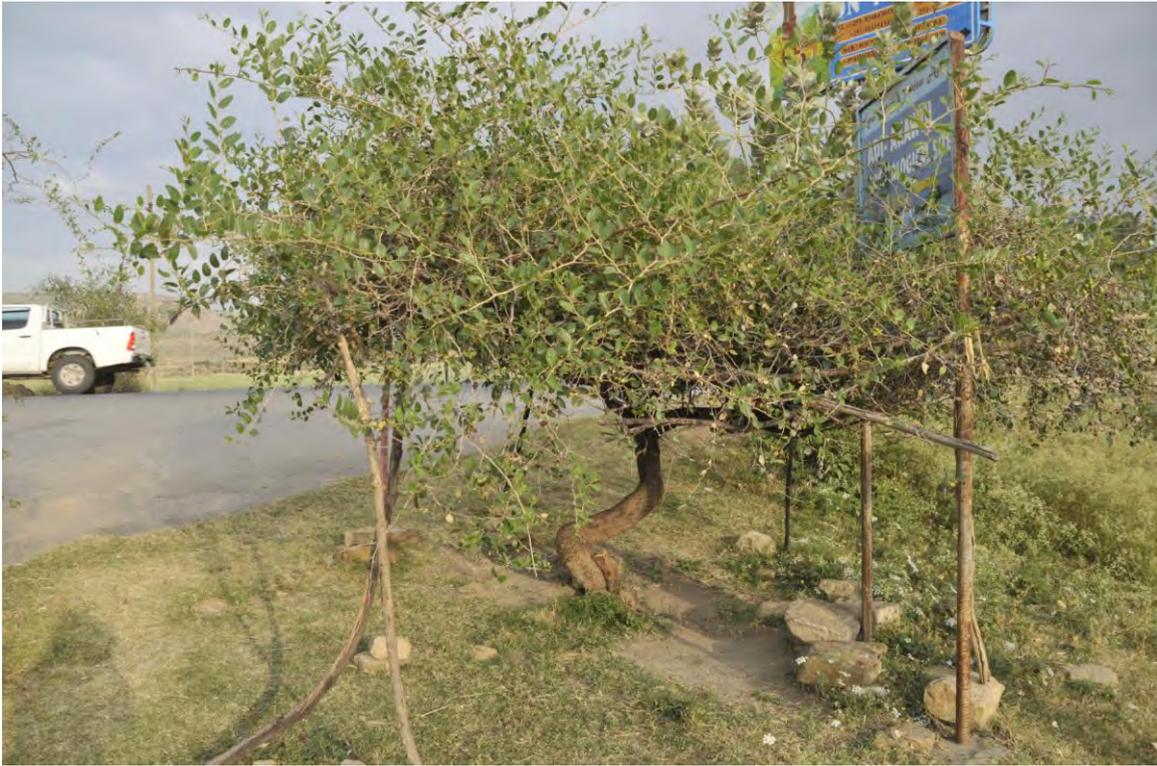
The sign positioned on the main Wuqro-Mekelle road, indicating the track to take to visit the open air museum at Meqaber Ga'ewa (Figure 19), is now completely obscured by a tree used to provide shelter for people waiting at the road side. This will need to be moved so as to be visible.

Figure 20: Tree obscuring the sign indicating direction toward the site Meqaber Ga'ewa positioned on the main road between Wugro and Mekelle (photograph: S. Matthews)
