# ETHIOPIAN-GERMAN EXPEDITION TO WUQRO

REPORT ON THE PRELIMINARY SURVEY OF ABUNA GARIMA AND SITE  
MANAGEMENT ACTIVITIES AT THE ALMAQAH TEMPLE AT MEQABER GA'EWA  
AND ZIBAN ADI, NEAR WUQRO

OCTOBER 2016

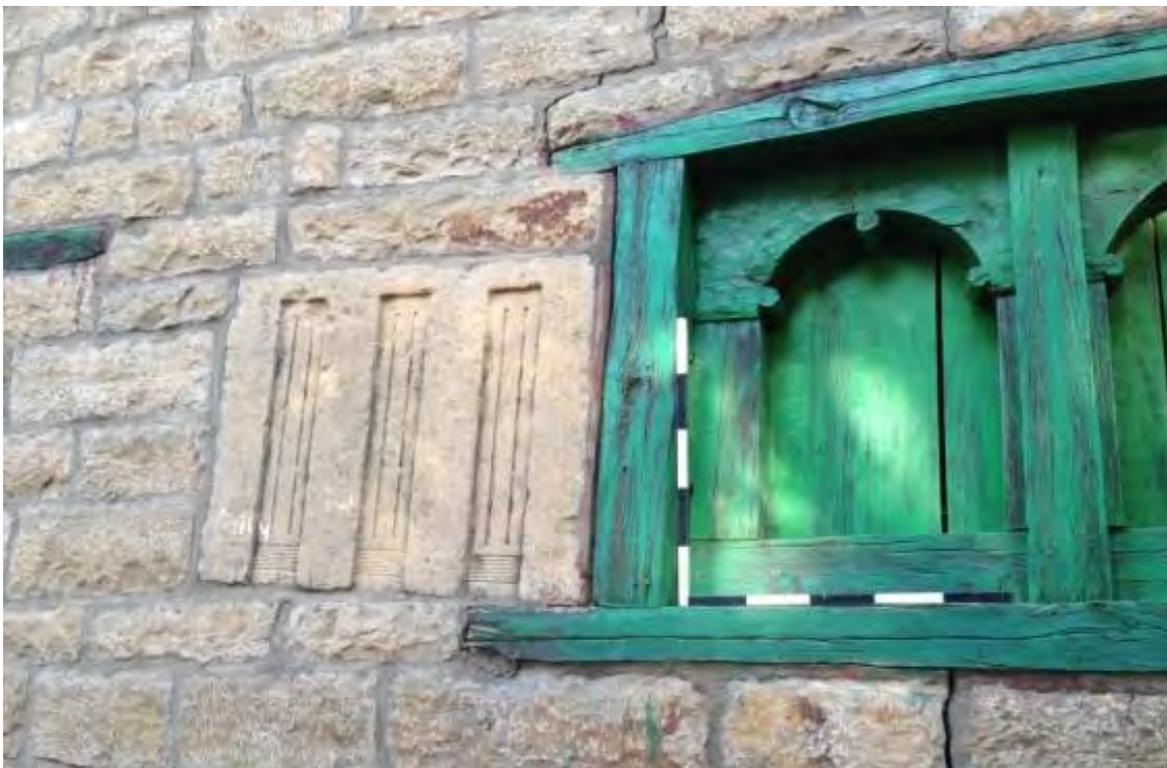
Incorporated into a window and a doorframe of the main church building are several large stone fragments from the carved facade of a pre-Aksumite altar in a Sabaeen style (Figure 3), similar to that discovered at Meqaber Ga'ewa. A further almost complete facade, probably from the same altar, was originally positioned near the gatehouse to the church compound but has now been moved by the priests into the church. The church also contains three large pre-Aksumite stone incense burners carved with Sabaeen inscriptions (Figure 4)

Figure 3: remains of a pre-Aksumite Sabaeen altar, now incorporated into the window of the west wall of the main church building (Area 1) (looking east) (photograph: S. Matthews)

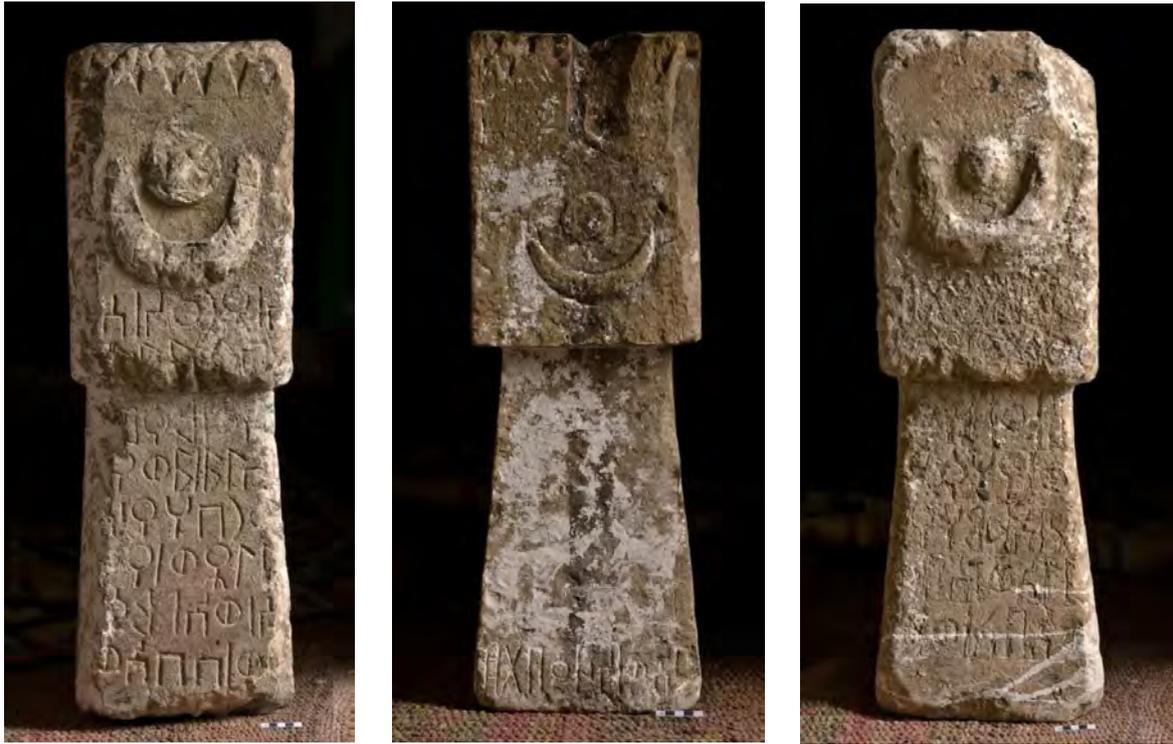
Figure 4: the pre-Aksumite Sabaean stone incense burners. currently stored inside the main church building (Area 1) (composite photograph: P. Wolf)

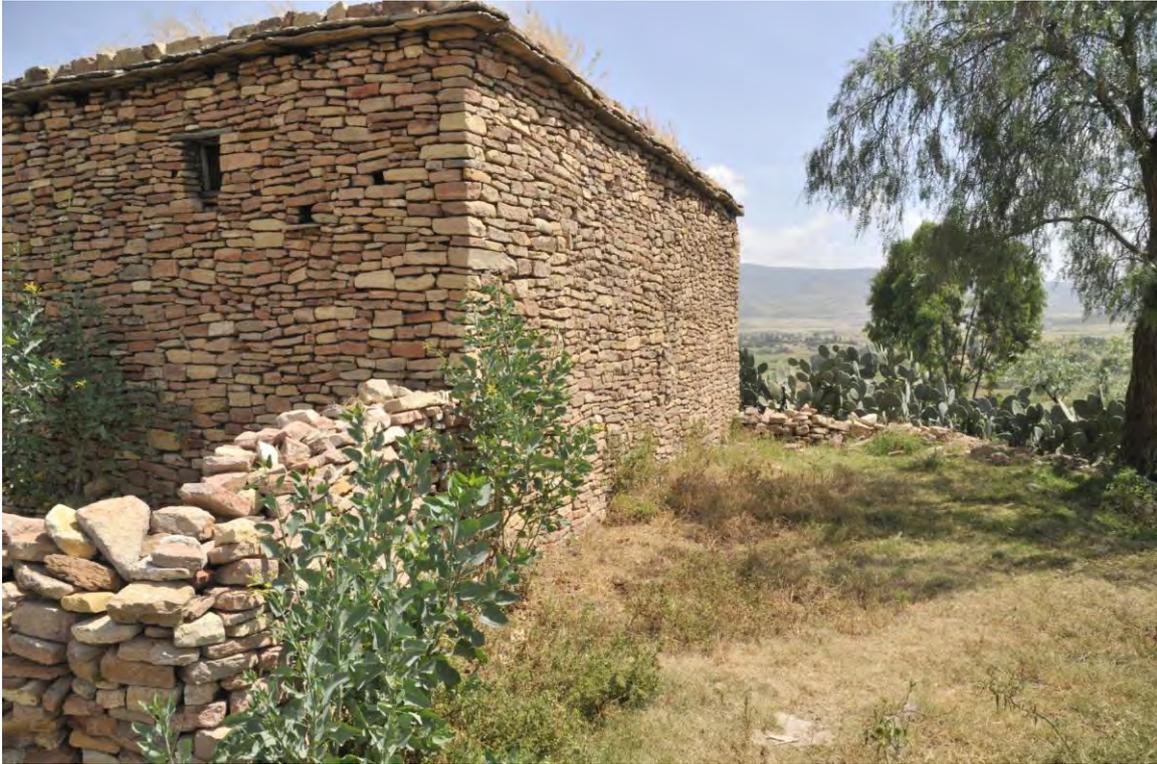
Area 2 is represented by a second large mound, located toward the centre of the village (Figure 1: Area 2). The entire mound appears to be enclosed by a single compound, comprising a large residential building (Figure 6) and several smaller ancillary buildings. The mound is accessed by a lane leading from the south up the southern face of the mound to the flat top (Figure 7), where the main building is located, and forms one of the largest buildings in the village. The compound is currently closed off, with access blocked by the construction of a dry stone wall across the entrance and the buildings having been padlocked. Despite this, there appears to be some occasional activity within the compound, as seen by the construction and use of a small earthen fireplace built next to the main building. The total area of the enclosure is made up of several different walled areas, most of which are now overgrown with trees and plants. No surface finds were noted and no structural remains identified. However, the melted redbrick and mortar feature (feature C) identified to the south of the mound in Area 3 extends most of the way up the eastern face of the mound to the summit.

Figure 6: the residential building located atop the central mound (Area 2) (looking east) (photograph: S. Matthews)

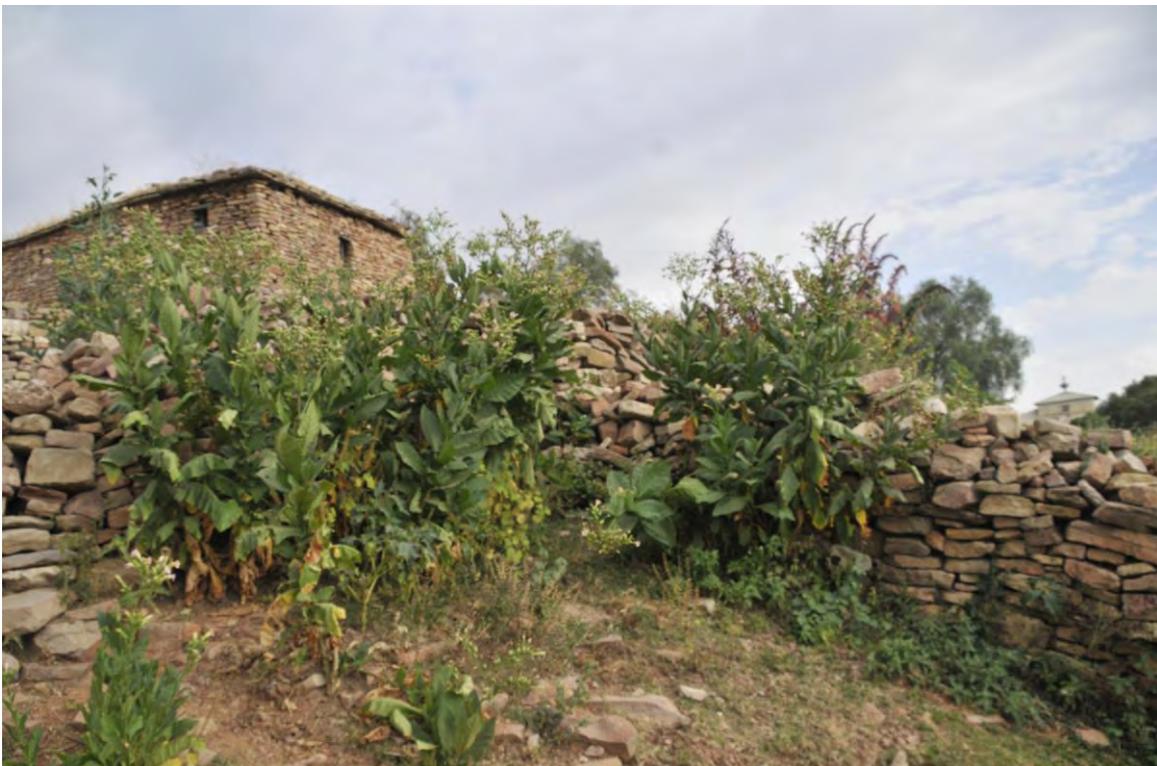
Figure 7: the lane leading up to the central mound (Area 2), now closed off by a wall (visible on the left side of the photograph), and the large residential structure on the top (looking southeast) (photograph: S. Matthews)

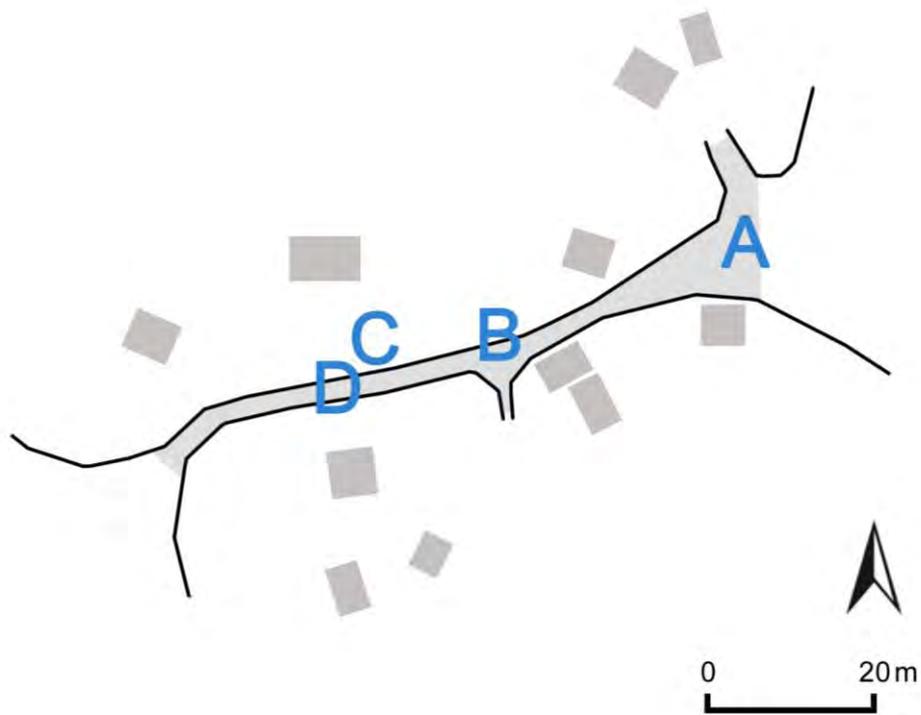
Area 3 comprises a lane running east-west that divides two of the large walled enclosures (Figure 1: Area 3). A number of archaeological features were identified along the length of the lane (Figure 8).

Figure 8: detail of the east-west running lane (Area 3), showing the location of the identified archaeological features (A-D) (map: S. Matthews)

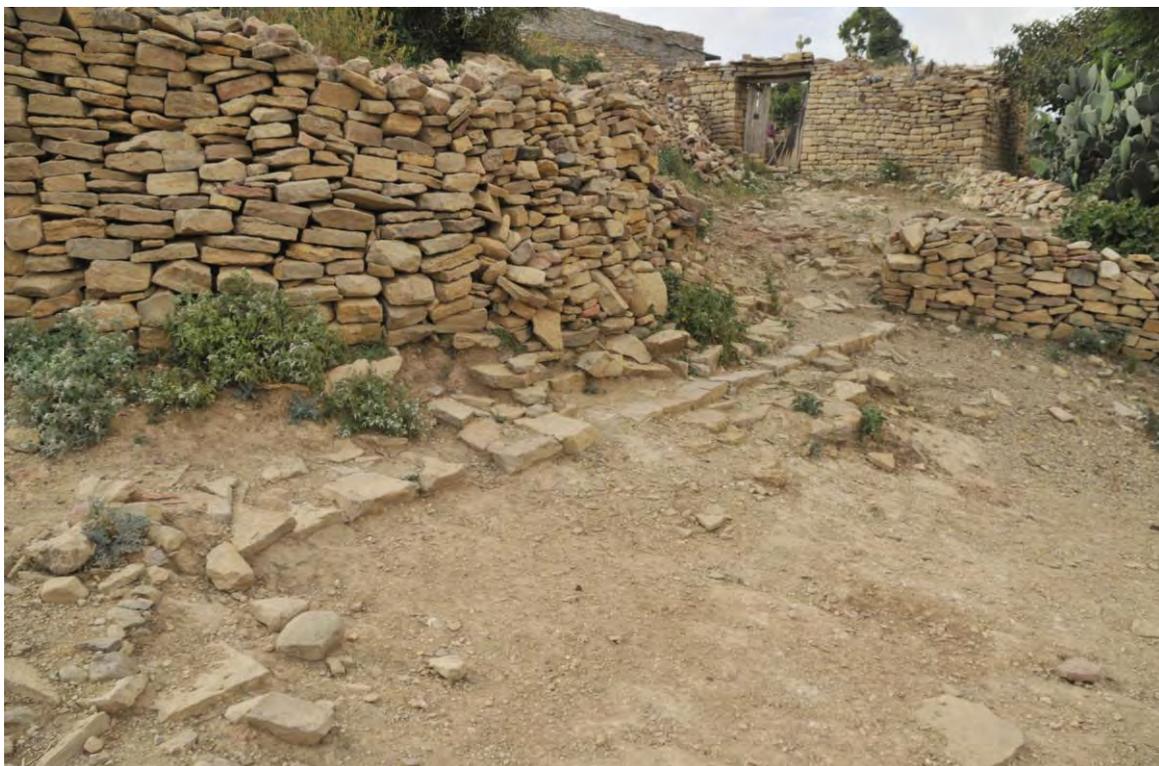
The first area (feature A) is represented by the remains of an in situ wall (Figure 9), situated at the eastern edge of the lane. This is the very eastern limits of the village and the escarpment, and is formed by a steep slope. The wall is visible as a consequence of the same heavy erosion processes that are affecting the entire eastern slope. The remains here form the corner of a structure, with the walls extending roughly to the north and east. The second (feature B) comprises the low remains of a limestone wall (Figure 10), constructed of roughly hewn blocks set within mortar, now incorporated into the foundation of a larger and less well constructed dry stone wall, which forms the northern face of the lane. The remains of the wall are orientated roughly east-west. The third (feature C) is a large feature consisting of a mass of melted redbrick fragments and mortar (Figure 11), some 60cm wide and 100cm tall. The feature is positioned at the eastern limits of the enclosure that forms part of the wall of the enclosure, interrupting the line of the dry stone wall. The feature

Figure 9: the structural remains of the corner of a building (Area 3, feature A), located at the end of the lane on the eastern limits of the village (looking north) (photograph: S. Matthews)

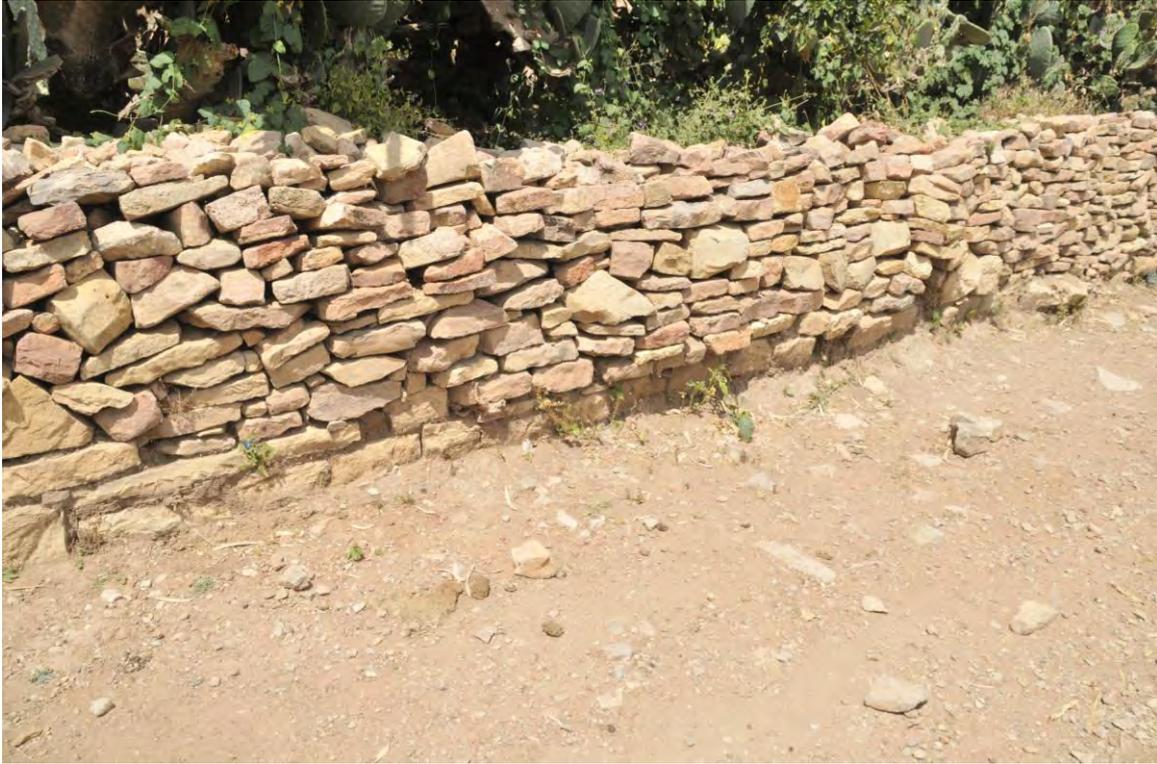
Figure 10: the remains of a well constructed limestone wall with mortar (Area 3, feature B), now incorporated into the base of a later dry stone wall, forming the western line of the lane (looking northeast) (photograph: S. Matthews)

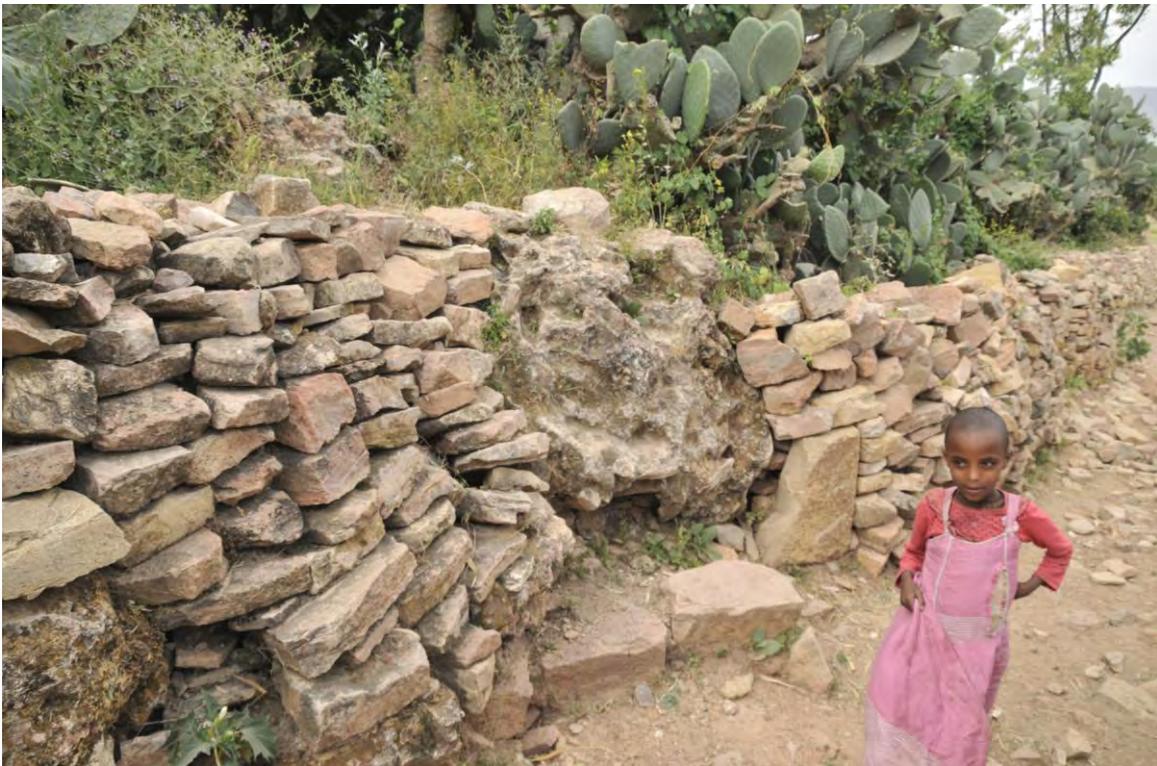
Figure 11: the western line of the dry stone wall, which incorporates the remains of a linear burnt redbrick and mortar feature (Area 3, feature C), which extends northwestwards up the southern slope of the central mound (Area 2) (looking northeast) (photograph: S. Matthews)

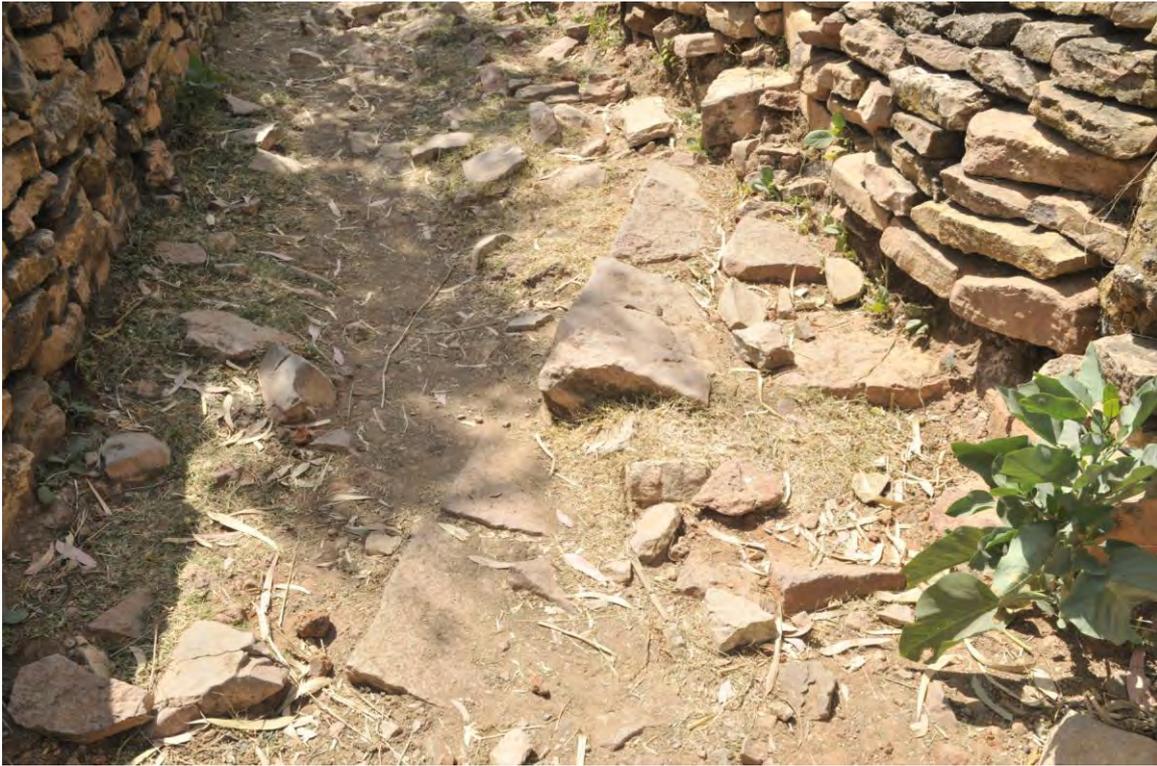
extends north-westwards for several metres, up the slope of the southern face of the central mound. The last (feature D) comprises the remains of three lines of in situ walls running northwest-southeast across the lane (Figure 12), on the same axis as the melted redbrick feature.

Figure 12: the remains of one of three identical stone walls that cut across the lane (Area 3, feature D) on a northwest-southeast axis (looking west) (photograph: S. Matthews)

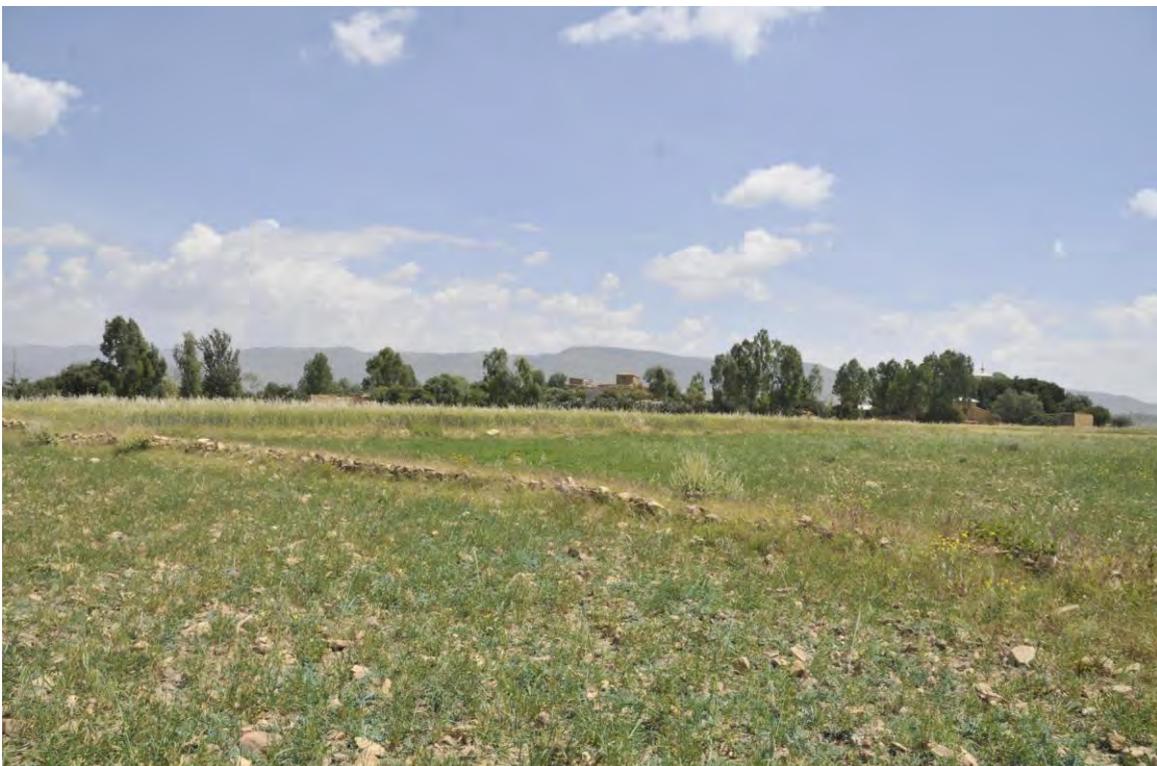
Area 4 represents a large area of fields lying immediately to the west of the village (Figure 13), enclosed within the arc formed by the western enclosure block of the village. At the time of the survey the fields were cropped and with deep furrows from earlier ploughing activities. The surface of the fields were replete with the fragmented remains of pottery vessels and grindstones, as well as a dense and even distribution of limestone fragments. The fragments of pottery ranged from small to large c. 10 x 10cm sherds, commonly with a red slip exterior and thin in profile. At the western limits of this area two large cairns or piles of limestone blocks had been erected (Figure 14), presumably from clearance of the fields prior to or during ploughing activities. One of these piles was older and now completely overgrown with wild brush, whilst the second was more recent and clear of plants.

Figure 13: the fields located immediately west of the settlement (Area 4) where dense concentrations of surface finds, including pottery and grindstones, were identified (looking east) (photograph: S. Matthews)

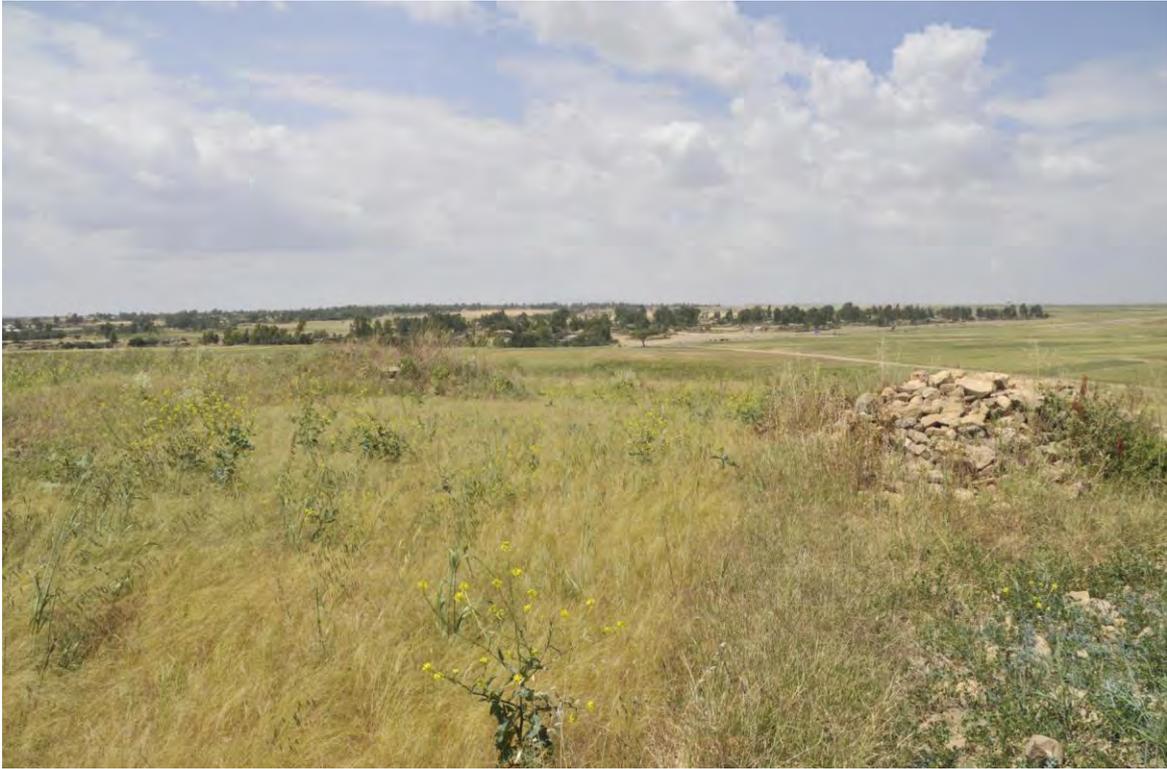
Figure 14: the two piles of limestone blocks (centre of the picture, now overgrown with brush, and on the right of the picture), collected from the fields during agricultural activities (looking west) (photograph: S. Matthews)
